2014 UTAH BOARD OF OIL, GAS AND MINING EARTH DAY AWARDS

Earth Day Nomination Rasmussen Excavation

Saturday Night Mine:

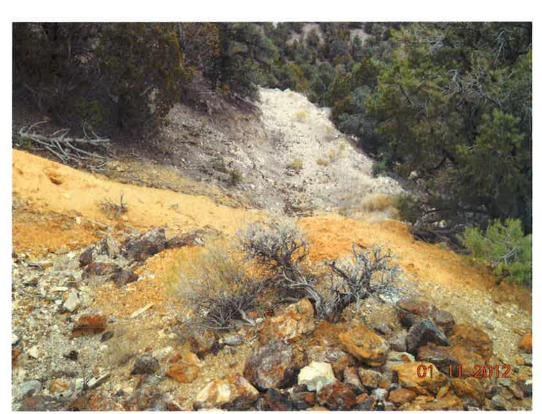
Photo 1: Dump #1 and access road prior to reclamation (upper pad)

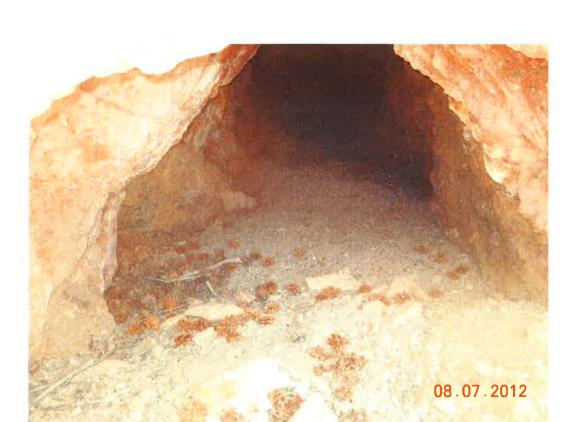
Photo 3: One of the three adits that was closed

Work began on November 27, 2012 and was finished the next day (November 28th). This was just over ½ the time expected for the project. Using a tracked excavator, access was made to the adits where material from the dumps was used to backfill and close them. Excess material in the dumps was used to backfill the cuts on the pads. This made it possible to regrade the pads and roads to approximate original contour. Large rocks and dead and down trees were placed on the pads and recontoured road to discourage use by off-road vehicles and ATV's. The road was also scarified and left in a roughened condition. The area was then seeded with a seed mix designed for the area and to enhance wildlife habitat. Seeding was completed the next day, and Mother Nature cooperated with the first major winter storm the next day.

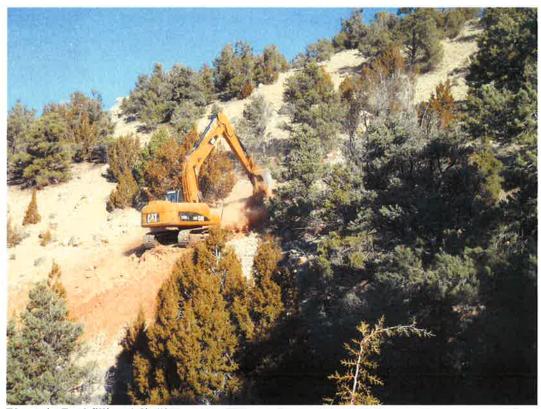
Photo 4: Backfilling Adit #2

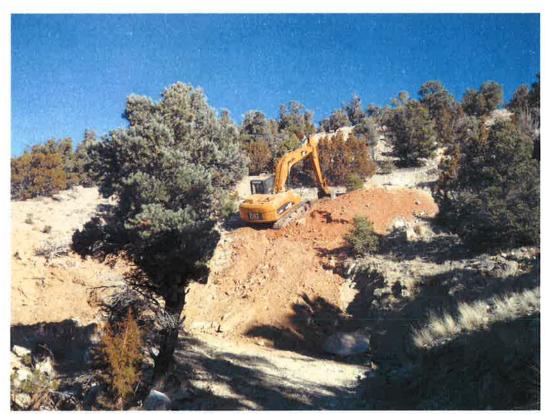
Photo 5: Reclaiming Dump #1

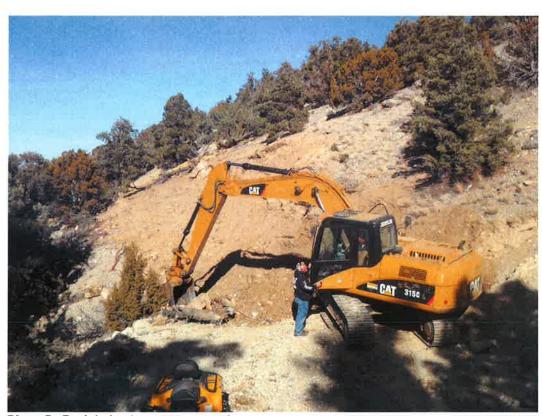
Photo 7: Reclaiming lower access road

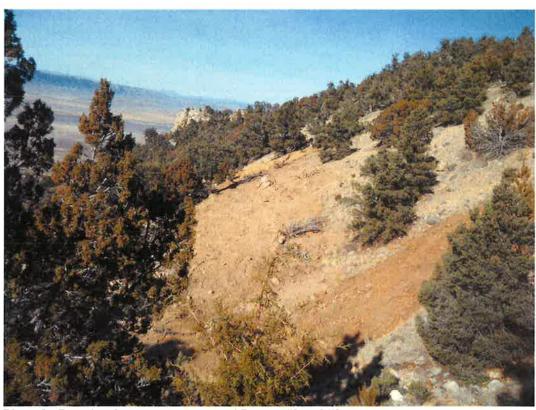
Photo 8: Reclaimed lower road, pad and Dumps #2 and #3

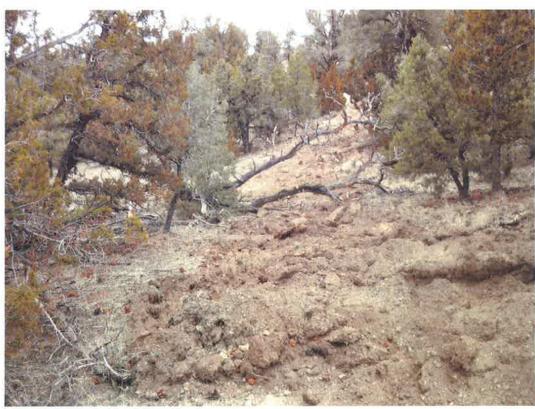
Photo 9: Reclaimed access road

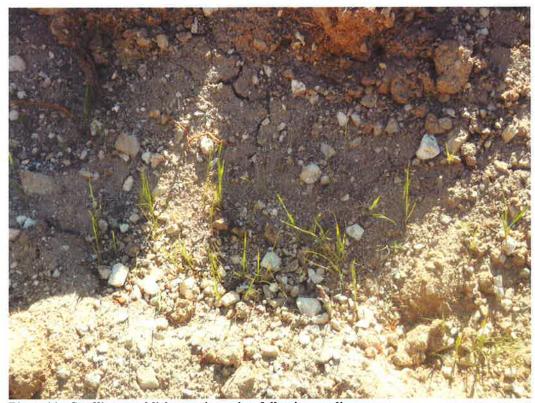
Photo 11: Seedling establishment in spring following seeding

The site was visited in June of 2013. The site was considered stable, and a variety of vegetation was observed growing on the reclaimed slopes.

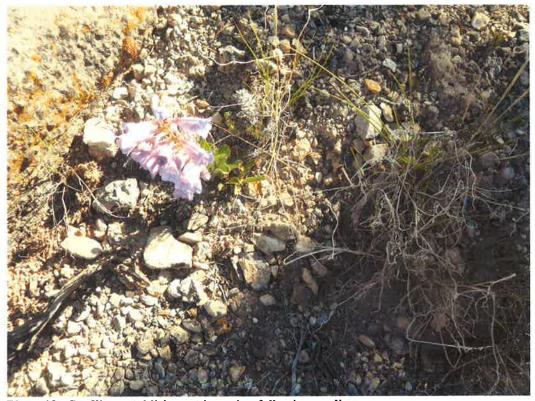
Photo 12: Seedling establishment in spring following seeding.
